In August 2003 the Port of San Francisco implemented an Arsenic-Treated Wood Inspection program. The intent of the program was to meet the spirit of the San Francisco Board of Supervisors Resolution No. 011-01-COE that required "all City departments who maintain existing playground and park equipment made of preservative-treated wood containing arsenic where contact with human skin is likely to occur ensure proper sealing in accordance with California Safety Health Code section 115775 until such time that all structures have been replaced with arsenic free alternatives." Although the Port of San Francisco does not maintain playground and park equipment its waterfront property is visited by millions of tourists annually.

The Port of San Francisco Arsenic-Treated Wood Inspection program identified location, type of structure, quantity of material, likelihood of contact with human skin, and action recommended. This information is compiled within the attached documents, along with photos of specific structures. The photos are numerically labeled to correspond with the information on the spreadsheet.

Arsenic-Treated Wood Inspection

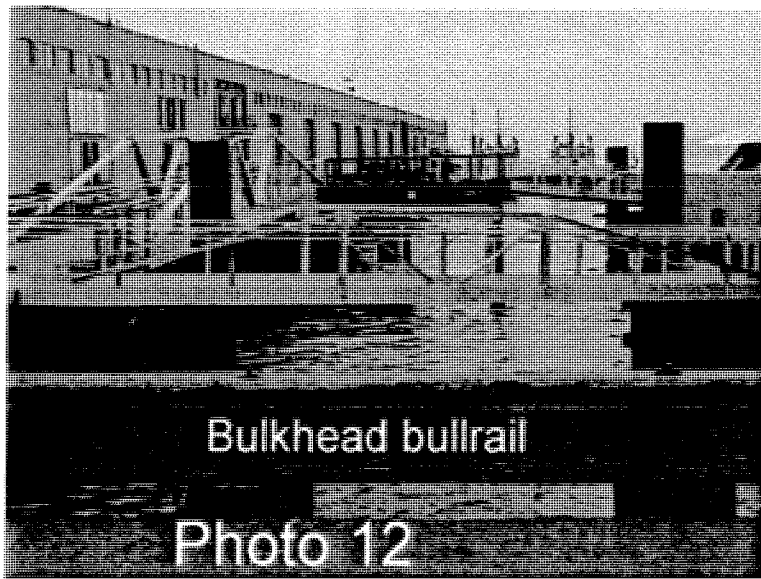
Photo 12

Pier 15/17	(12)	Bull rail on Bulkhead	341 l.f. 12x12 Bullrail	#12	Photo #12 is P-Q South Apron	2		Minimum to moderate contact by public. People occasionally observed sitting, eating. Recommend testing.
Pier 9	(13)	North side Bull rail, deck bulk head between 9 and Waterfront Restaurant	788 l.f. Bullrail and Bulkhead 2020 sq. ft. decking	#13		2		Light contact by bar pilots and employees. Light foot traffic. No significant contact with skin.
AG Building (south of Pier 1)	(18)	Bull rail	228 l.f. Bull rail	#18 No photo		2		Minimum contact.

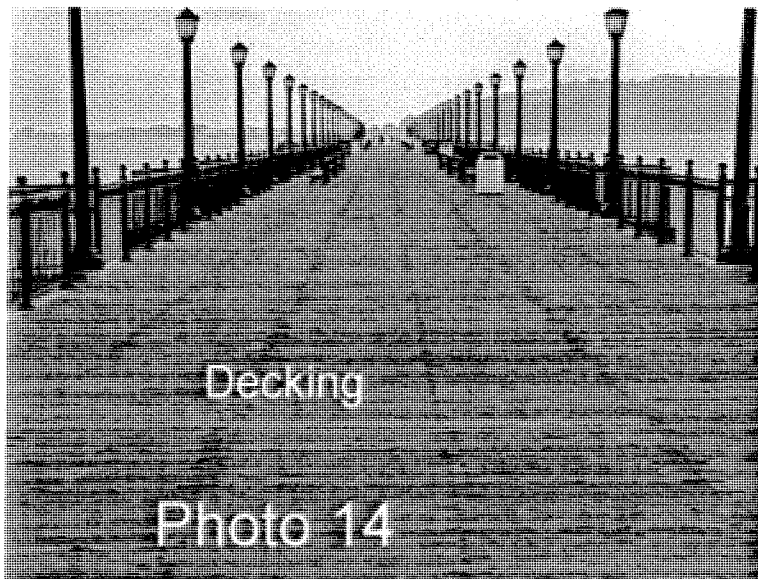
Photo 14

Pier 7	(14)	Decking	33.272 sq .ft. decking	#14		3		Heavy foot traffic by public. Recommend testing @ east end where heavy use by fishermen.
Pier ½	(15)	2 x 12 Decking bullrail 4 x 12 Decking	7,718 sq. ft. Decking 340 l.f. Bull rail	#15		3		Moderate foot traffic, moderate contact. Light foot traffic, no significant contact, other seating available.
Pier 96	(1)	Bull rail on face	2630 l.f.	See A 12 typical		3		Minimum contact.
Pier 94 Ask about Pier 90	(2)	Bull rail on face	94 & 96 combined	See A12 typical		3		Minimum contact.
Public Launch Ramp Ask about Pier 54	(5)	Decking	310 sq. ft. 210 + 70	A5		3		Light contact by bar pilots and employees. Light foot traffic. No significant contact with skin.
Eye Institute (near Pier 50)	(7)	Parking lot bull rail	570 l.f. bull rail	A7		3		Minimum contact
Pier 38 and 36	(9)	Decking and bull rail North side	4280 sq. ft. decking 155 l.f. bull rail	A-9		3		Moderate contact by employees and others. All foot traffic.

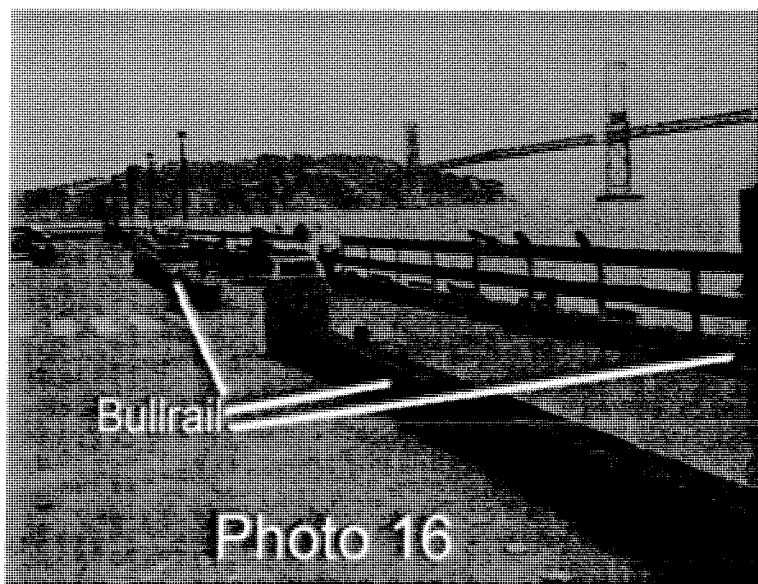
Photo 16

Ferry Plaza and World Trade Center	(16)	Bull rail	1757 l.f. Bullrail	#16		2		Moderate contact by public. Other seating available.
Hyde St. Harbor (8/15/03)		Deck				3		Used for pedestrian traffic, sitting or touching deck unlikely.
Pier 43.5, Fog Bell area		Benches	3			3		Handrail in this area are all untreated redwood.
Pier 47 (Scomas)	(4)	Decking, Bullrail	8600 sq. ft Decking 20 l.f. Bullrail	#4		3		Much foot traffic by Scoma customers and other tourists. Table set up on treated decking. Est 10+ years since instll'n. Recommend for testing?

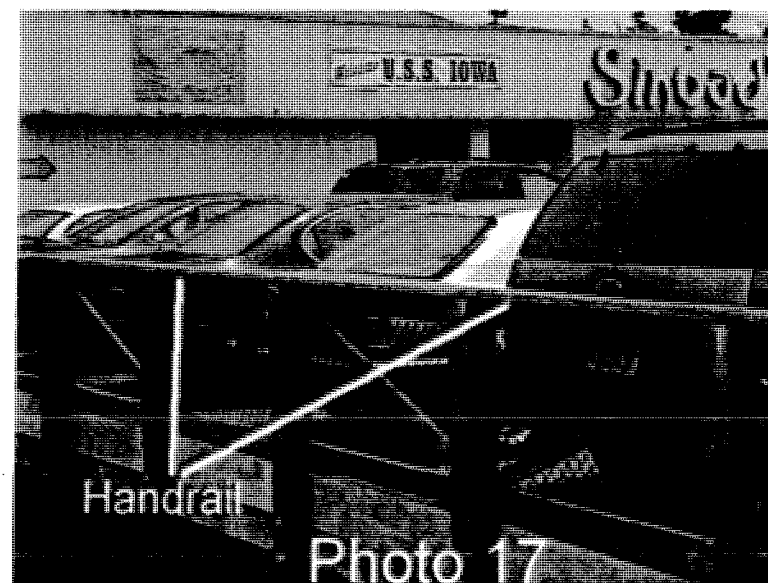
Photo 17

Sinbads	(117)	Hand rail	117 l.f. Handrail	#17		1	8	Moderate contact by customers
Hyde St. Harbor		Bull-rail, east edge of parking lot	150 ft	002		2		Harbor users or visitors observed or likely to sit on bullrail at dock-side.

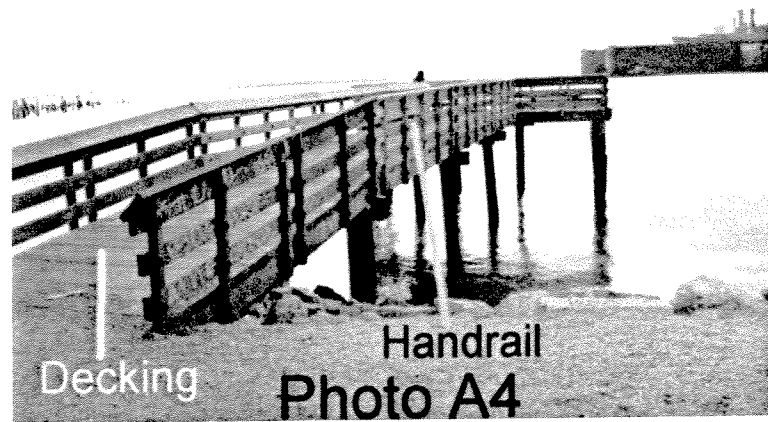
Decking
Handrail
Photo A4

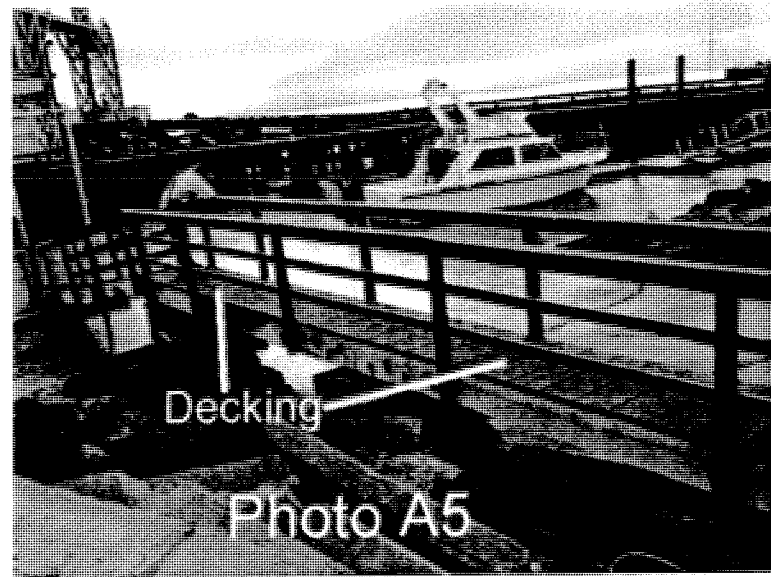
Decking
Photo A5

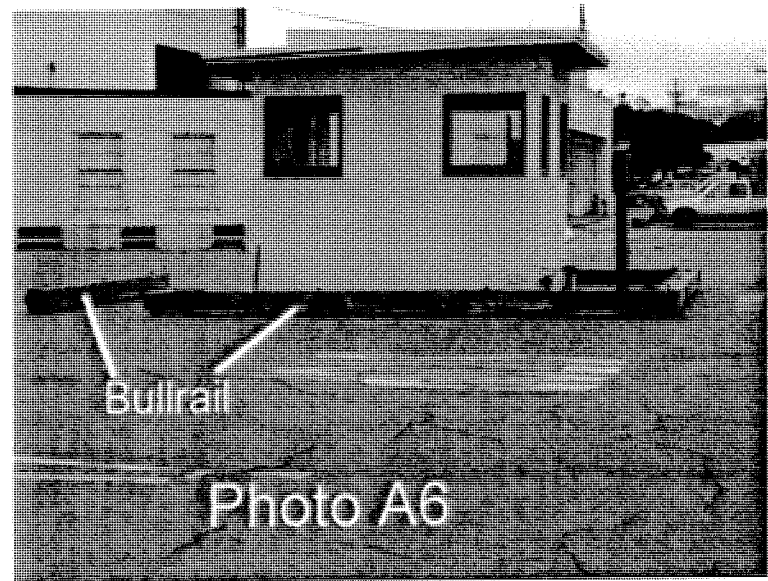
Bullrail
Photo A6

Pier 80	(3)	Bull rail south side and face	3825 l.f.	See A12 Typical		2		Minimum contact by longshoremen.
Pier 80	(3)	Bull rail south side and face	3825 l.f.	See A12 Typical		2		Minimum contact by longshoremen.
Pier 50D	(6)	Bull rail in front of shed and bull rail around guard shack	165 l.f. Bull rail	A6		2		Minimum contact
Jelly's	(8)	Bull rail in front	40 l.f. bull rail	A8		2		Minimum contact
Bulk Head between Pier 38 & 36	(10)	Bulk head bull rail	137 l.f. 12x12 bull rail	A-10		2		Minimum to moderate contact by public. All foot traffic.
Bulkhead between Piers 34 & 36	(11)	Bulk Head bull rail	590 l.f. 12 x 12 bull rail Pier 36 to Pier 32	A-11		2		Minimum to moderate contact by public.
Bulk head between Piers 36 and 32	(12)	Bulk head bull rail		A-11		2		Minimum to moderate contact by public.
Pier 30-32	(13)	Bull rail around pier	1920 l.f. bull rail	A-12		2		Minimum contact
Pier 22½ Firehouse	(15)	Decking and bull rail	1932 sq. ft. Decking	A-14		2		Moderate contact by firemen. Minimum contact by public. All foot traffic.

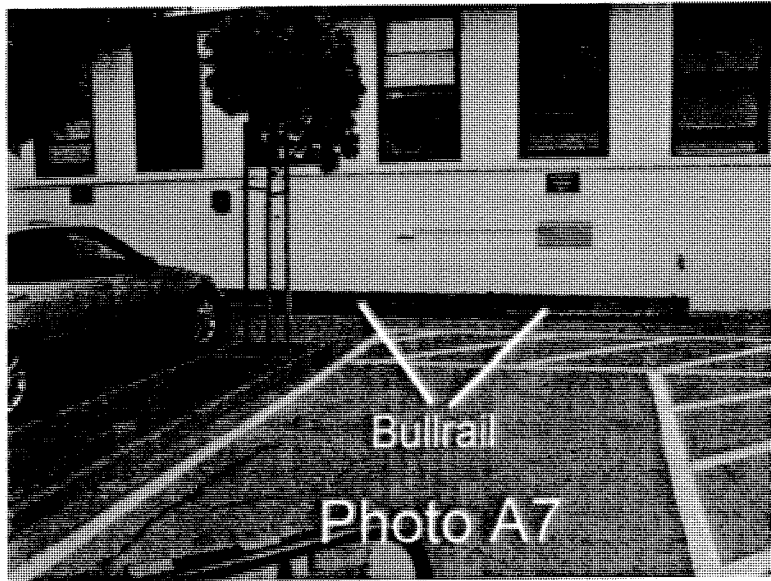
Bullrail
Photo A7

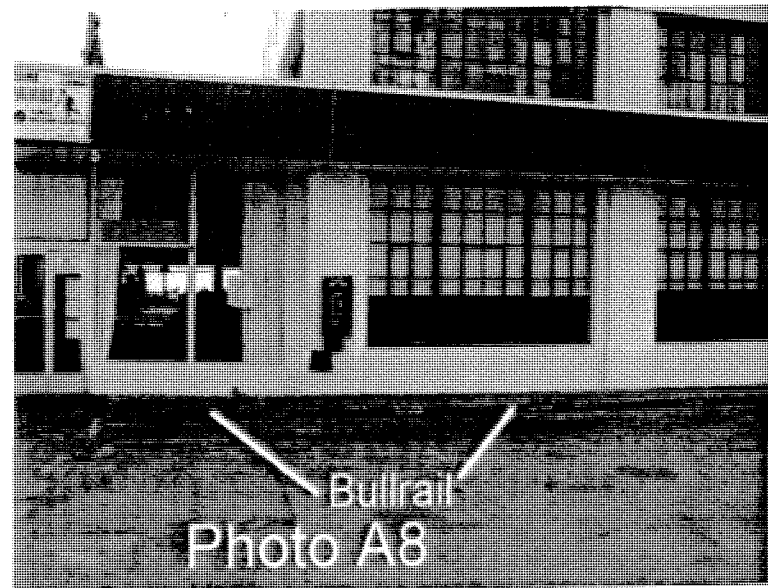
Bullrail
Photo A8

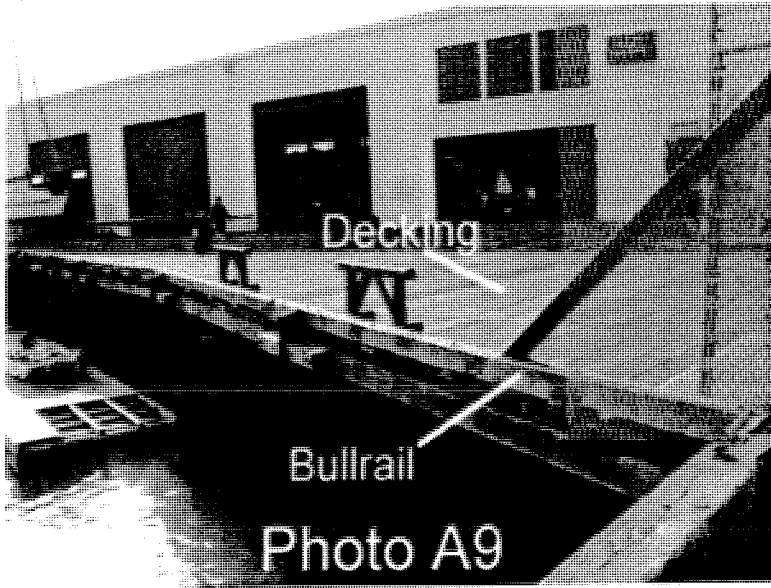
Decking
Bullrail
Photo A9
